# FIXED IMPRESSIONS WORK MAT

## Most Common Problems with Fixed Impressions

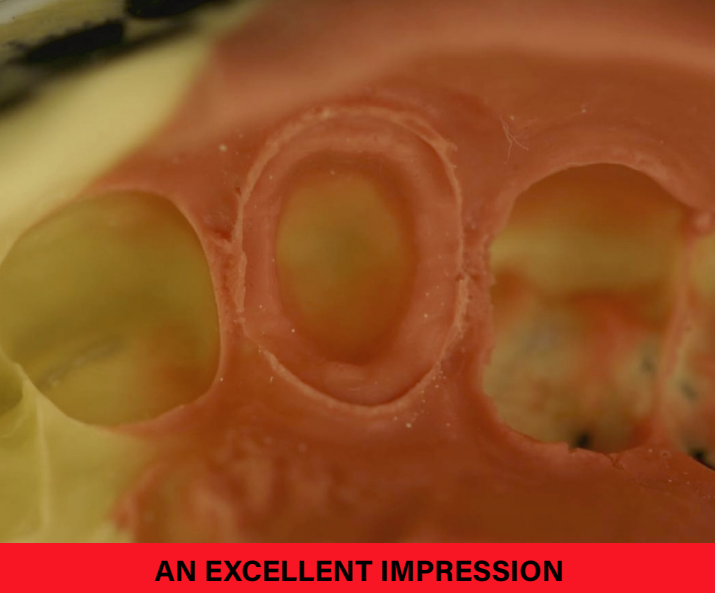
**AN EXCELLENT IMPRESSION**

- No tearing of the wash from the putty around the preparation
- Detailed and complete margins
- No tooth contact with tray; impression centered on tray
- Tray adhesive applied properly
- Properly mixed material; no streaking
- Strong bond between tray and wash materials; no signs of debonding or ledges
- No voids; full, smooth wash material coverage

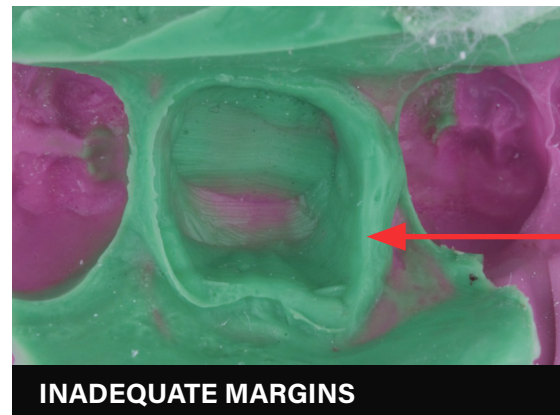
**INADEQUATE MARGINS**

- Incomplete sulcular expansion around the preparation
- Improper moisture control around the preparation
- Exceeding the material's working time
- Tray movement after seating

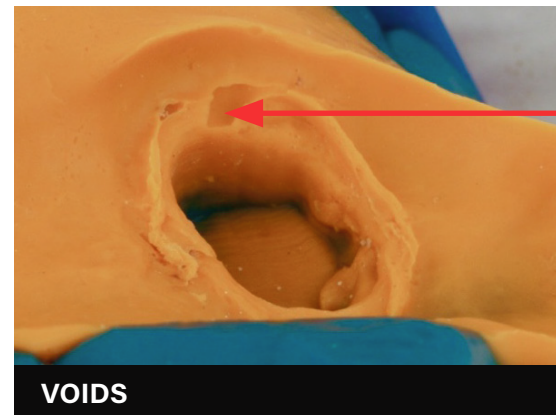
**VOIDS**

- Improper syringe technique
- Sulcular fluid/bloods/contaminants
- Incomplete sulcular expansion around the preparation
- Tray incorrectly seated
- Insufficient preparation covered by the impression material

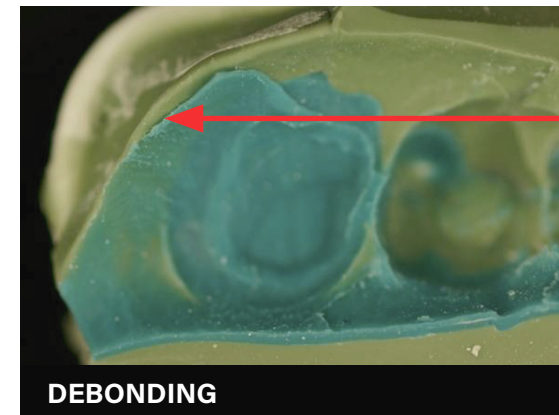
**DEBONDING**

- Exceeding the material's working time
- Contamination of tray material
- Impression material stored at a temperature above manufacturer's recommendation

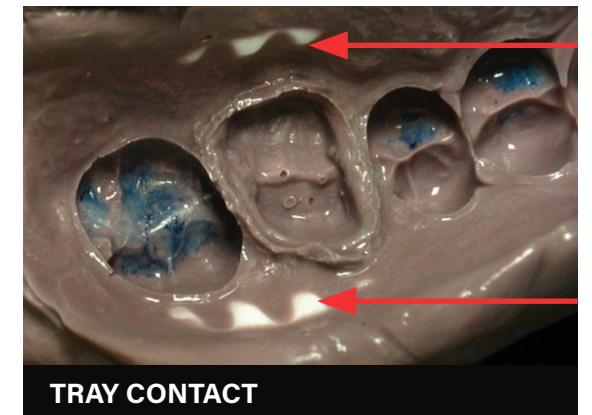
**TRAY CONTACT**

- Incorrect tray size used
- Tray not oriented correctly
- Insufficient impression material used

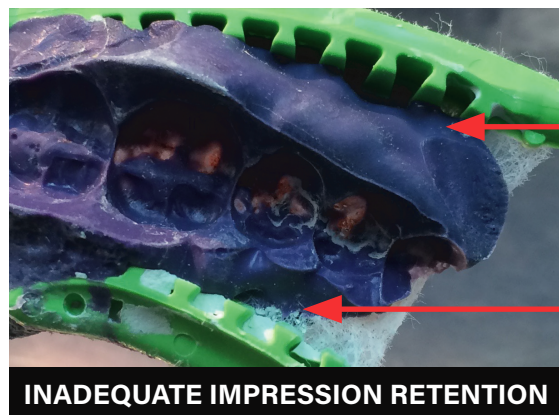
**INADEQUATE IMPRESSION RETENTION**

- Insufficient impression material used
- No tray adhesive used
- Inadequate tray adhesive drying time
- Outdated impression material used

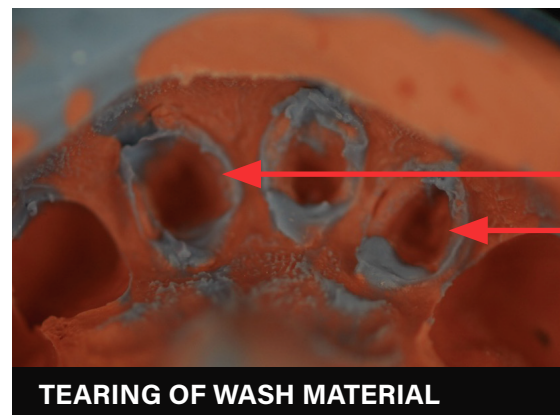
**TEARING OF WASH MATERIAL**

- Insufficient retraction around the preparation
- Impression removed before material has set
- Improper moisture control around the preparation
- Outdated impression material us

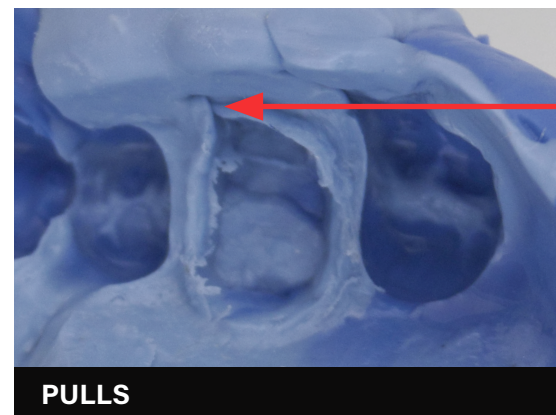
**PULLS**

- Exceeding the material's working time
- Tray movement after seating the impression
- Insufficient impression material used
- Rapid seating of the impression tray

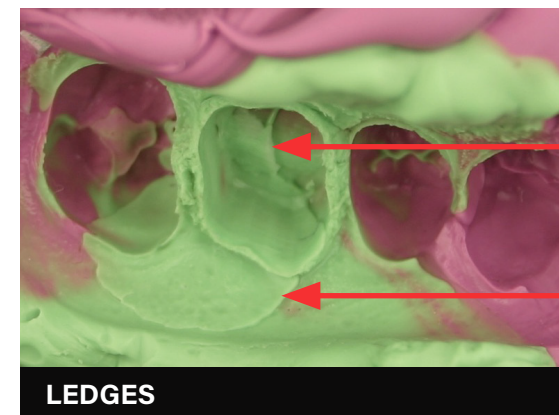
**LEDGES**

- Preparation of most posterior tooth is contraindicated with dual-arch trays
- Buccal, lingual and posterior tray contact
- Lack of occlusal clearance
- Extreme mesh exposure

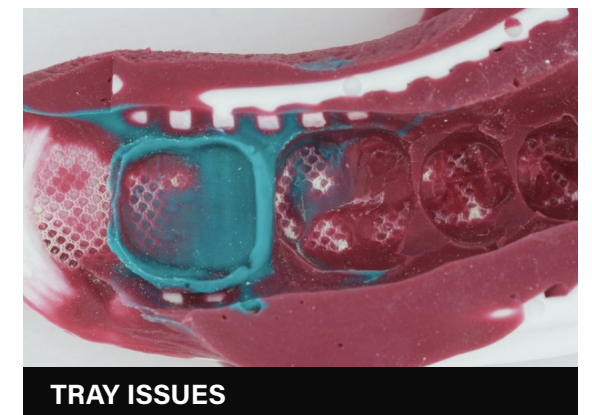
**TRAY ISSUES**

- Incomplete sulcular expansion around the preparation
- Improper moisture control around the preparation
- Exceeding the material's working time
- Tray movement after seating
